Soapi SOLAR

**Typical
Improvement
In Solar Yield
When PV Panels
Are Cleaned**

**CASE STUDY
04/09/2023**

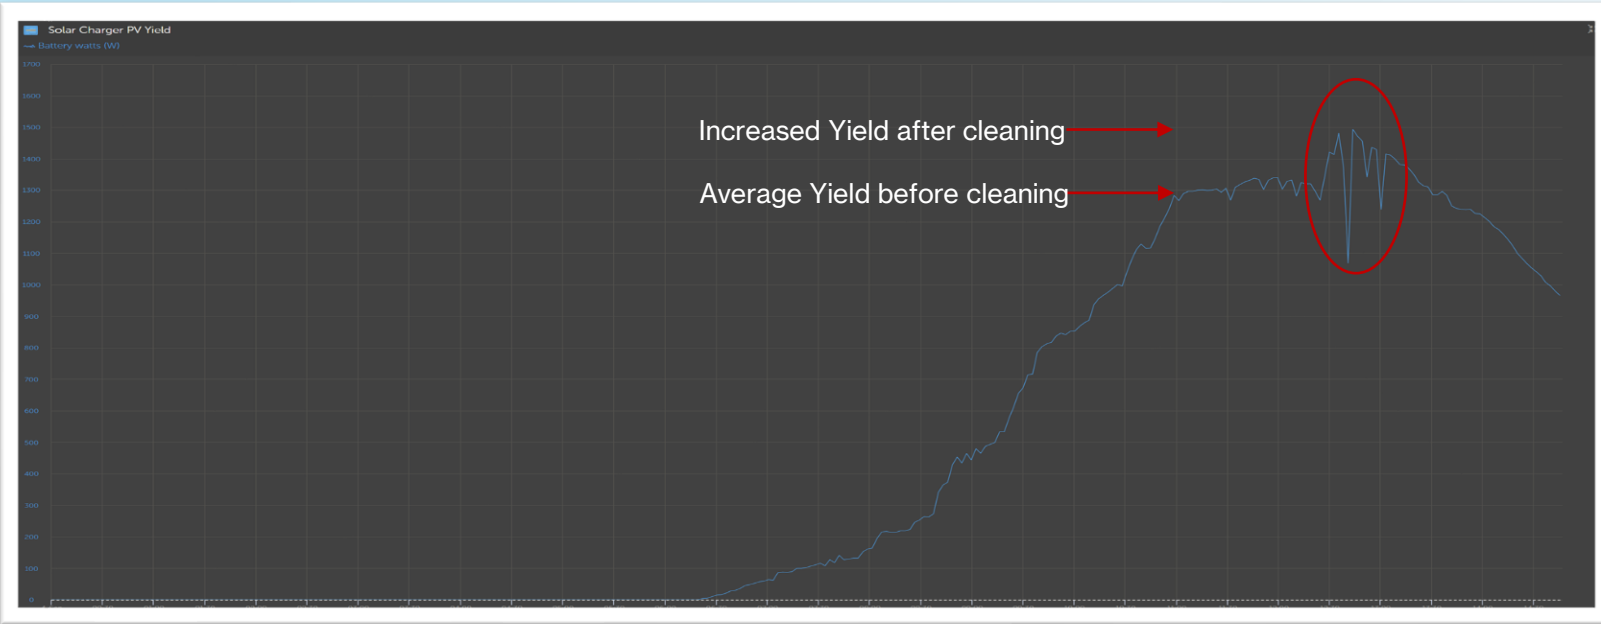
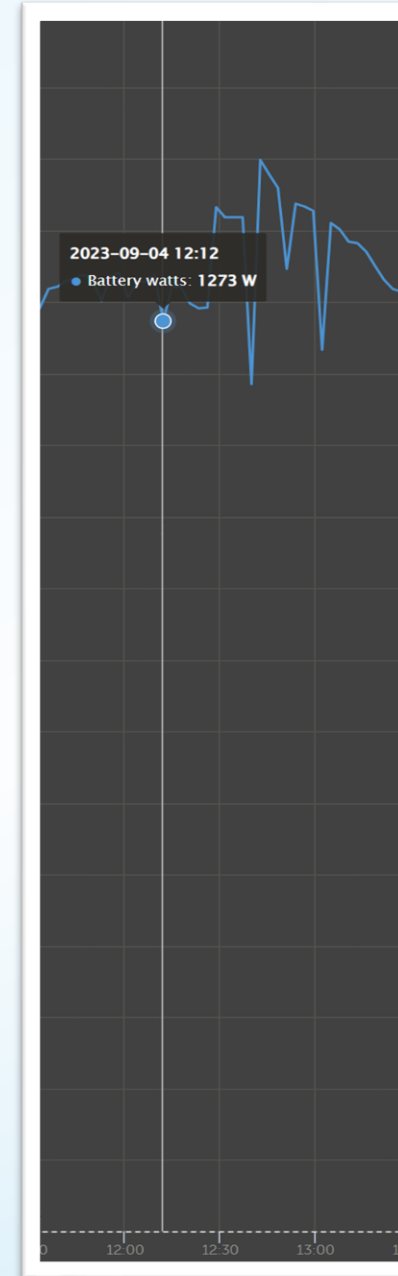
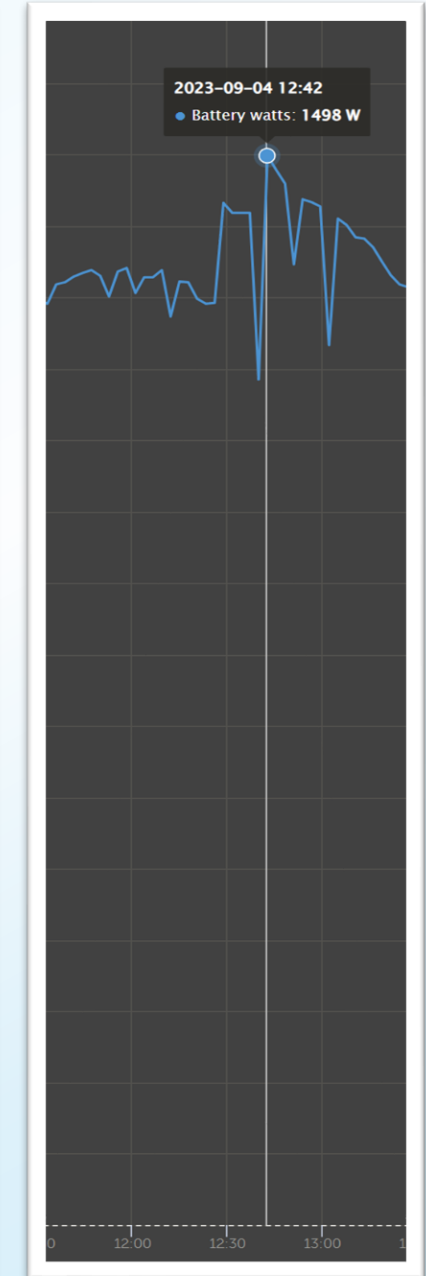
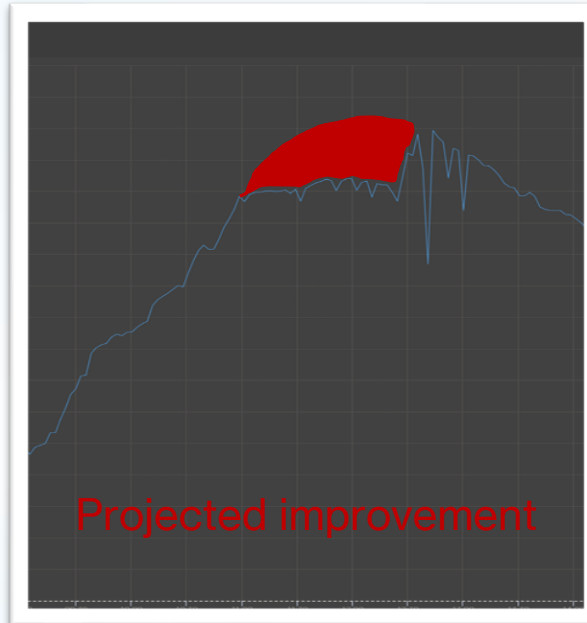
PV ARRAY 1 - NORTH FACING

Yield just before cleaning @ 12 H 12 : 1273 Watt
 Yield just after cleaning @ 12 H 24 : 1498 Watt
 Improvement in Watt : 225 Watt
 Improvement % wise : 15 %

- The power sampling in this recordings was done at 5-minute intervals and the deep dips are the results of shading caused by the cleaning person.

12-year-old PV array facing North - DC coupled MPPT

Cleaned by using a soft brush and particle free water – no soap.

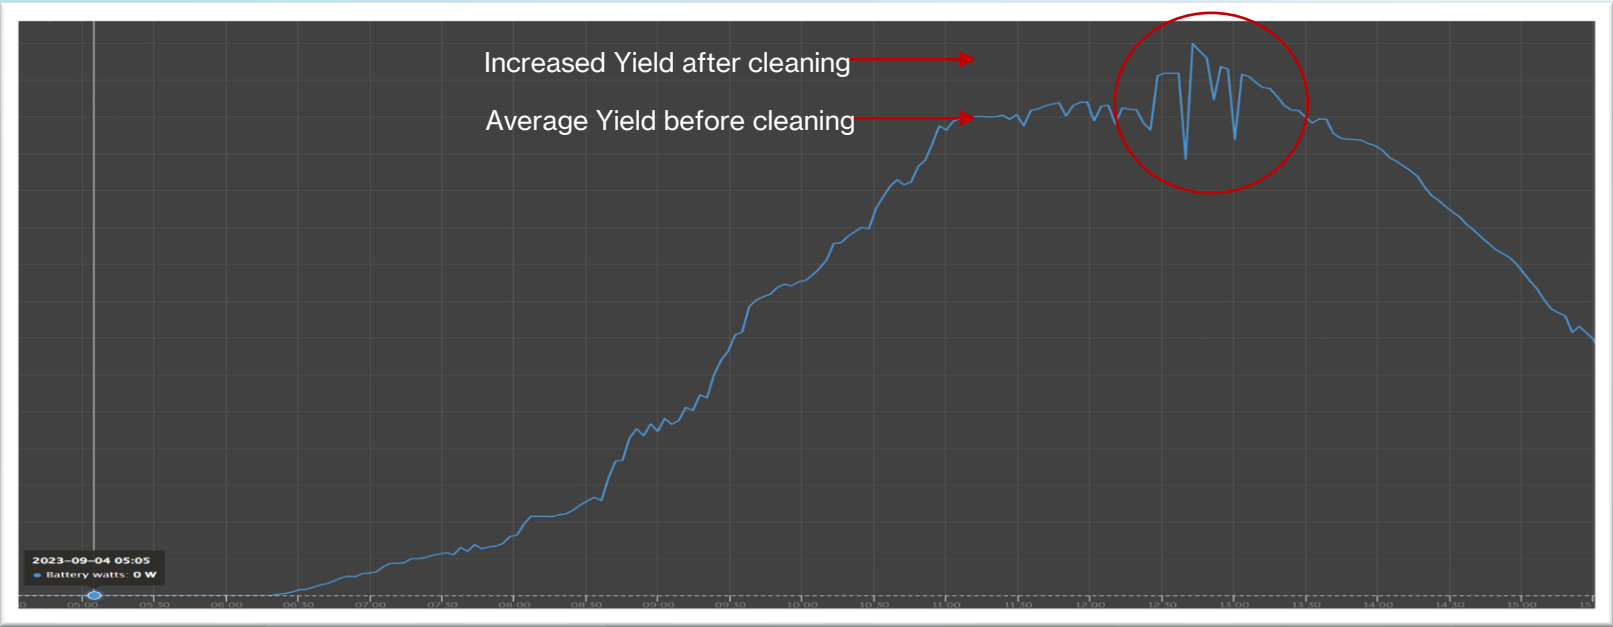
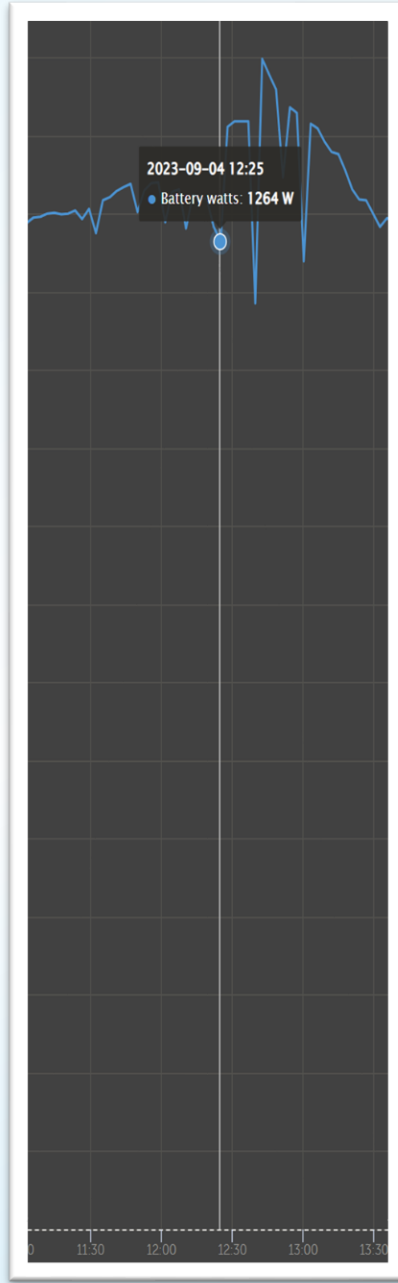
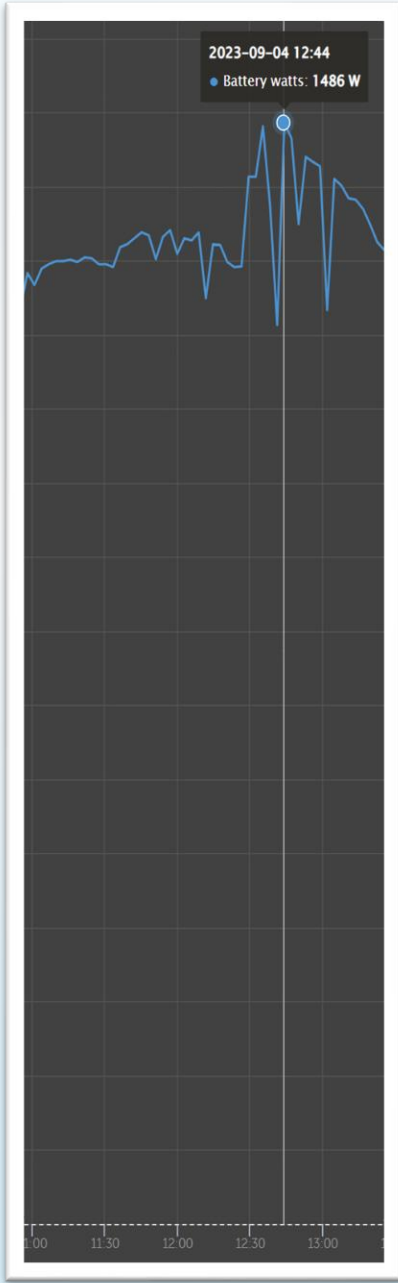
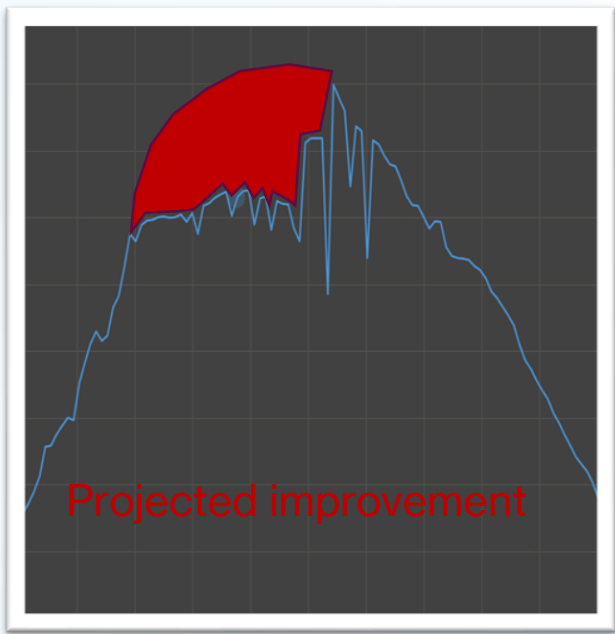
PV ARRAY 2 - EAST FACING

Yield just before cleaning @ 12 H 25 : 1264 Watt
 Yield just after cleaning @ 12 H 44 : 1486 Watt
 Improvement in Watt : 222 Watt
 Improvement % wise : 14.9 %

Please note:
 • The power sampling in this recordings was done at 5-minute intervals and the deep dips are the results of shading caused by the cleaning person.

12-year-old PV array facing East - DC coupled MPPT
 Cleaned by using a soft brush and particle free water – no soap.

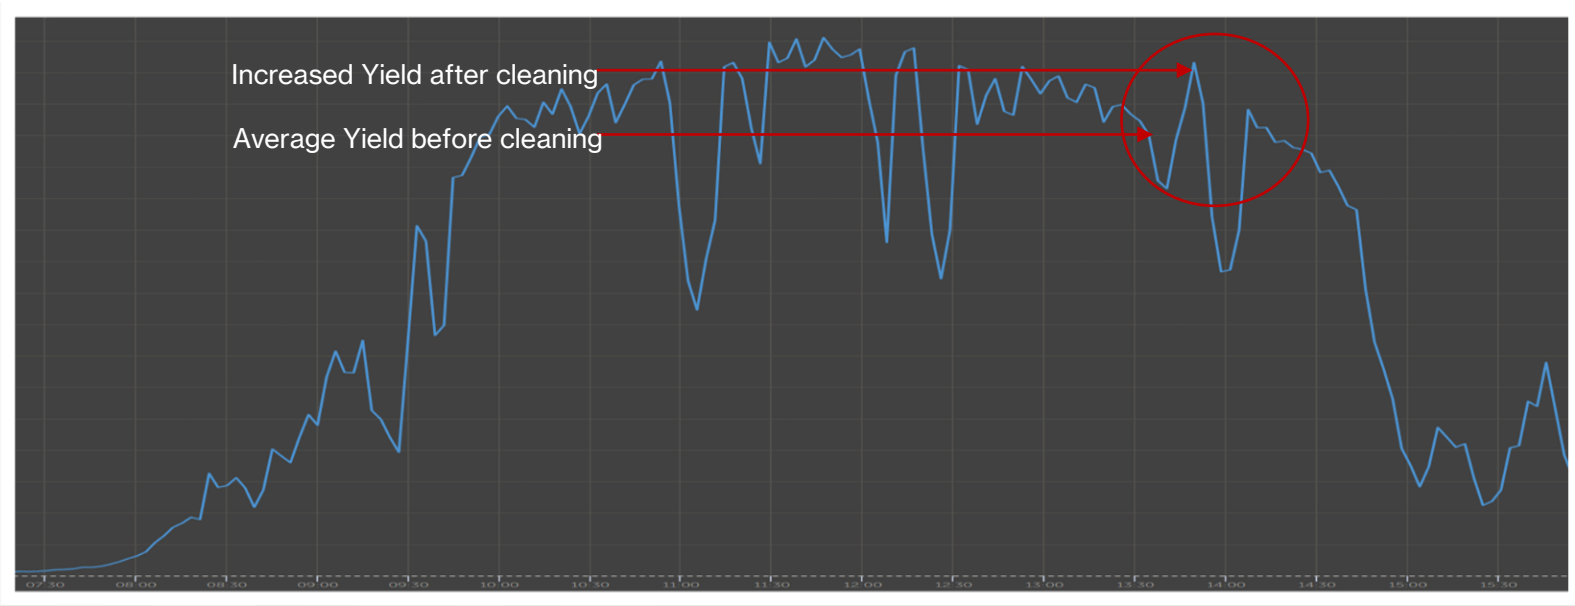
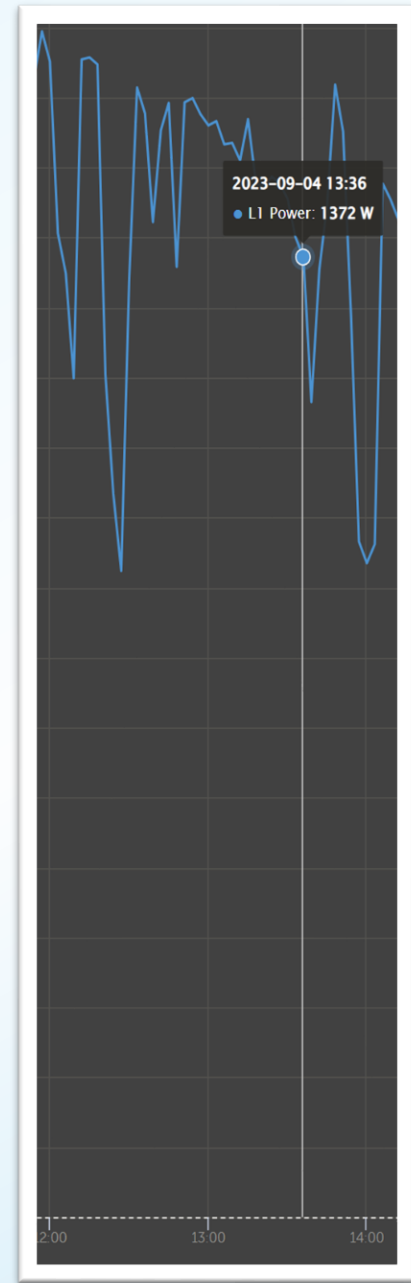
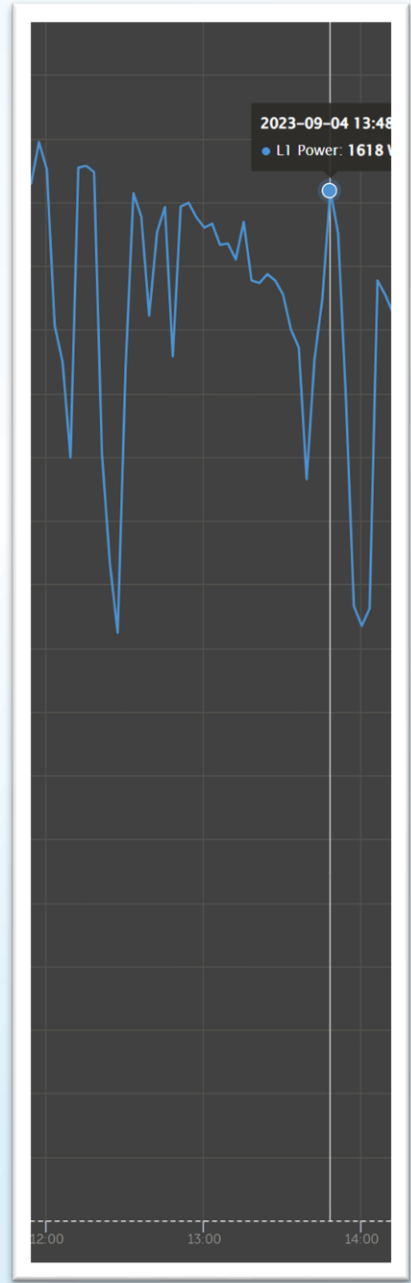
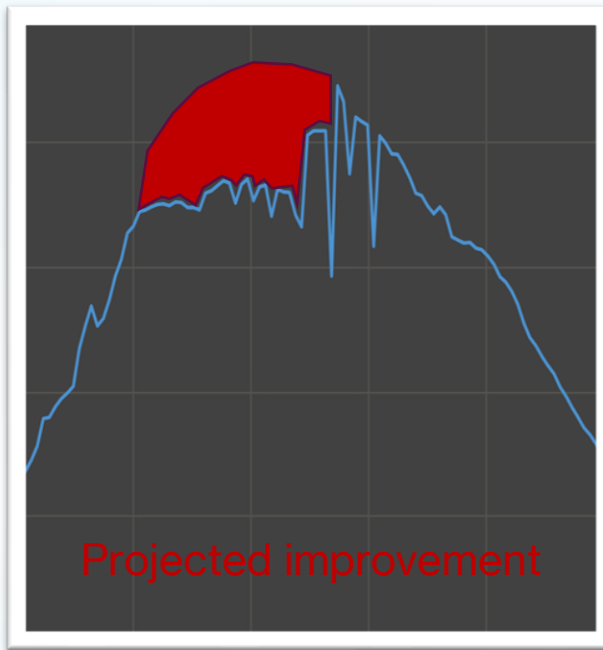
PV ARRAY 3 - NORTH FACING

Yield just before cleaning @ 13 H 30 : 1372 Watt
 Yield just after cleaning @ 13 H 48 : 1618 Watt
 Improvement in Watt : 246 Watt
 Improvement % wise : 15.2 %

Please note:
 • The power sampling in this recordings was done at 5-minute intervals and the deep dips are the results of shading caused by the cleaning person.

12-year-old array facing North - DC coupled MPPT
 Cleaned by using a soft brush and particle free water – no soap.

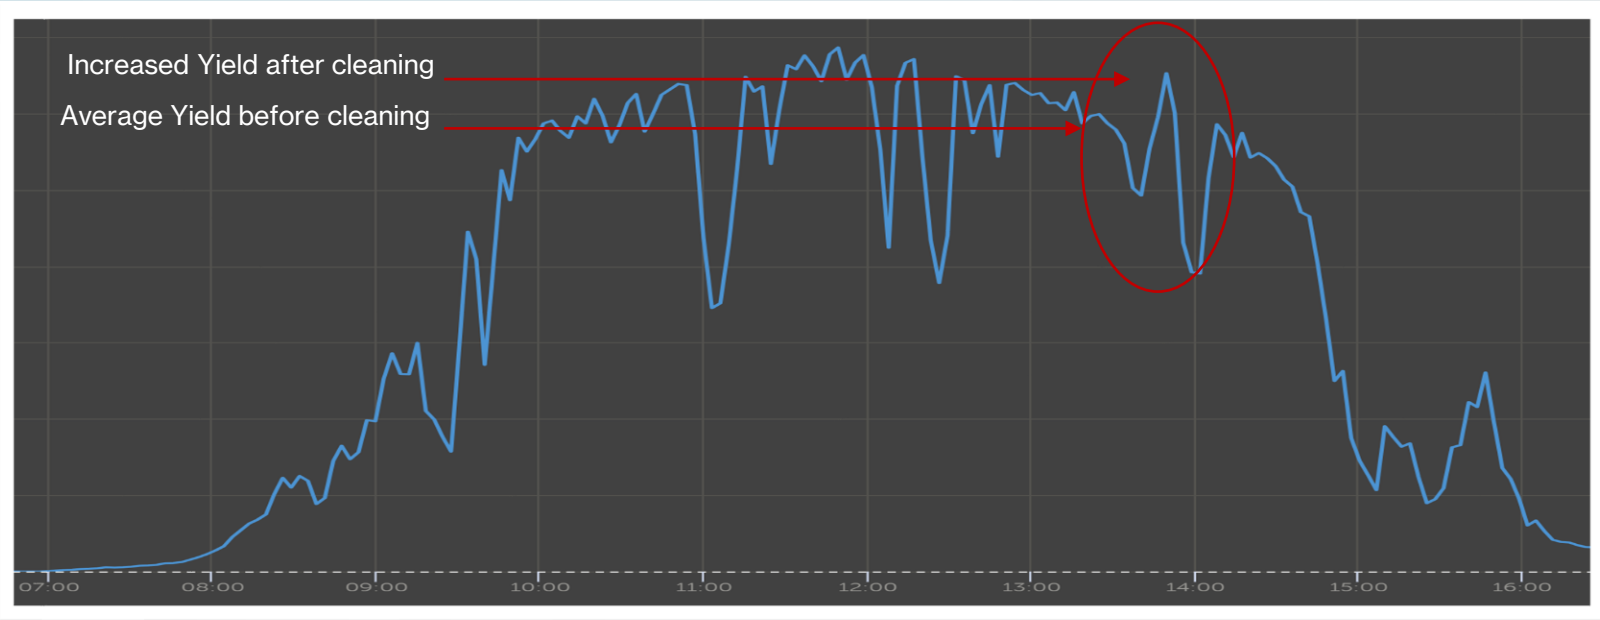
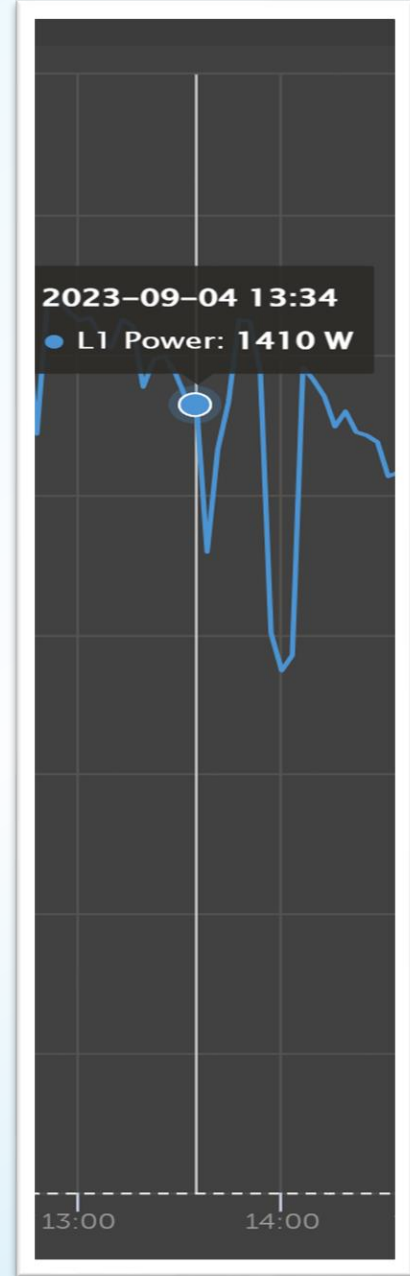
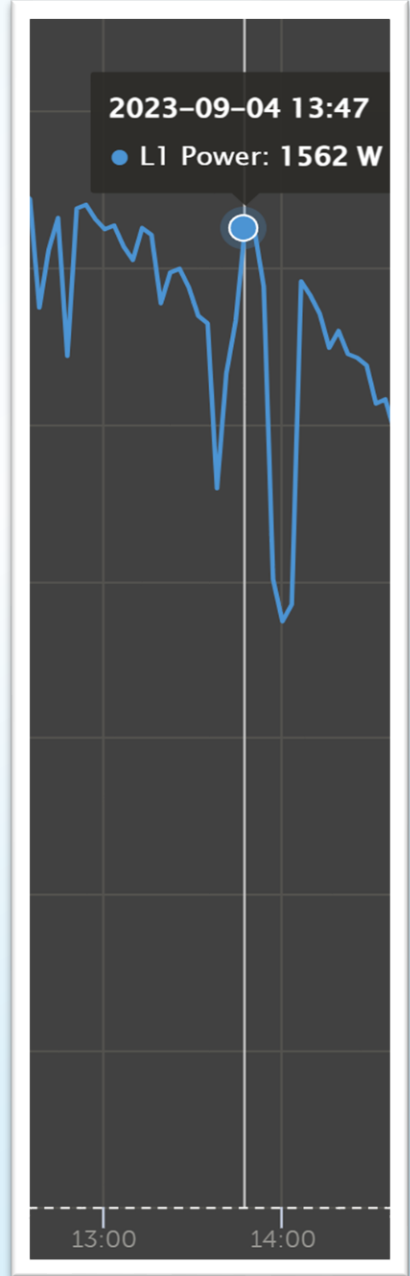
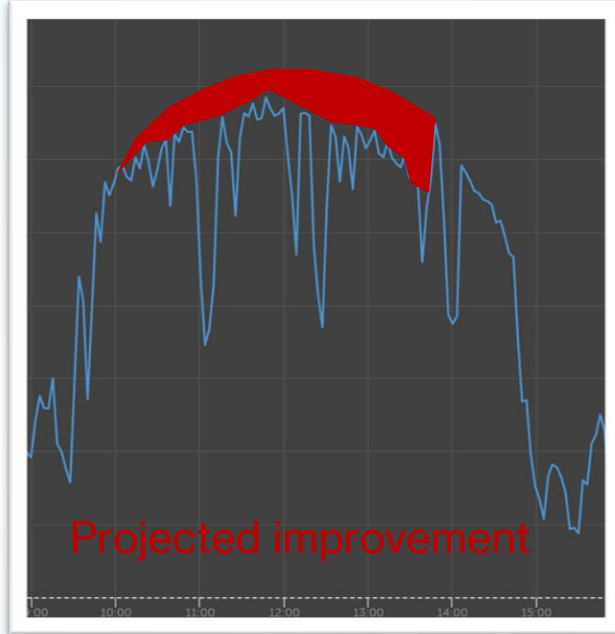
PV ARRAY 4 - NORTH FACING

Yield just before cleaning @ 13 H 34 : 1410 Watt
 Yield just after cleaning @ 13 H 47 : 1562 Watt
 Improvement in Watt : 246 Watt
 Improvement % wise : 9.7 %

- Please note:**
- This measurement was done at a time when shading from a palm tree was setting in, thus not a good example.
 - The power sampling in this recordings was done at 5-minute intervals and the deep dips are the results of shading caused by the cleaning person.

10-year-old array facing North - AC coupled Grid Tied Inverter

Cleaned by by using a soft brush and particle free water – no soap

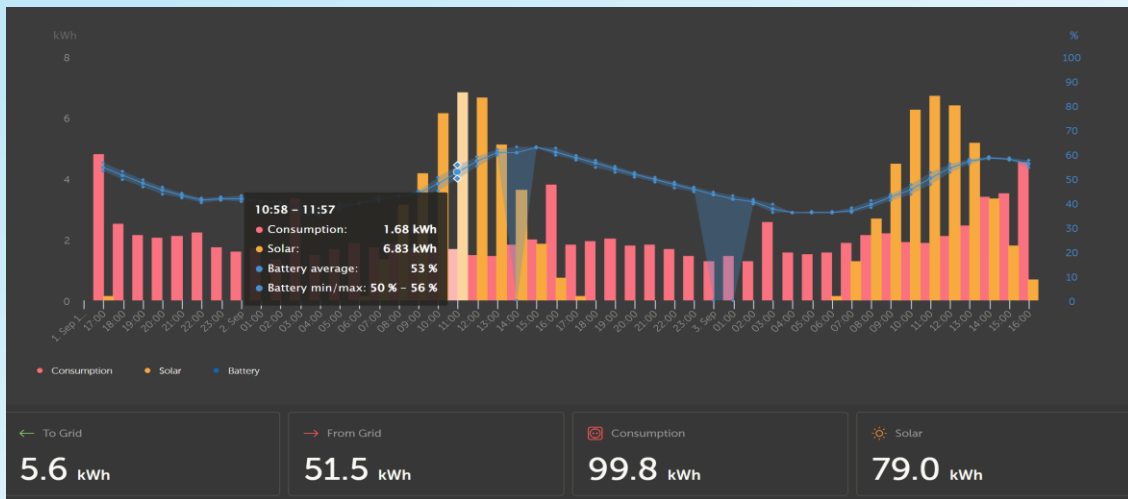
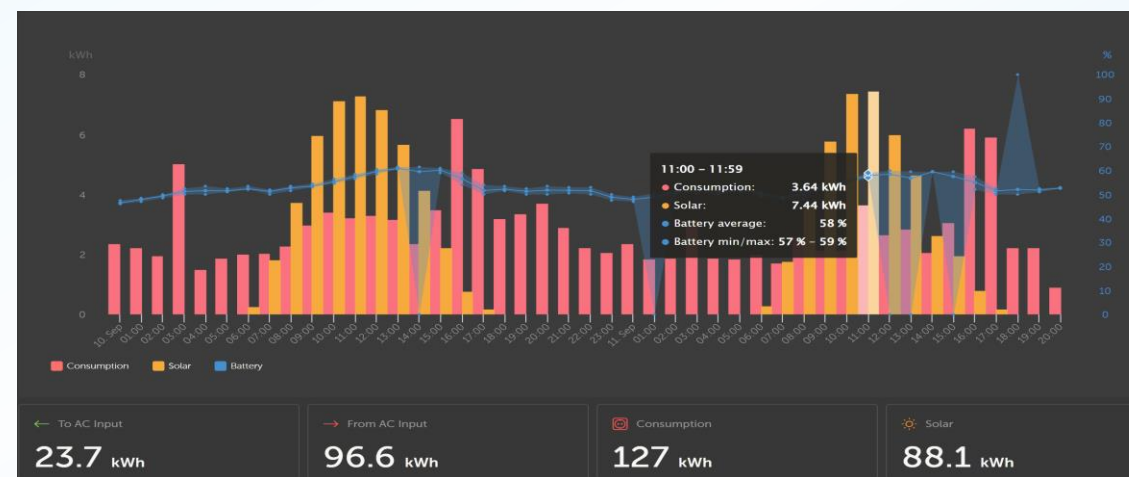
IMPROVEMENT IN DAILY YIELD MEASURED OVER A 2 DAY PERIOD BEFORE AND AFTER CLEANING

The peak power - around mid day - for the total PV array **2 days PRIOR to cleaning** the panels was **6.83 kWH** and **6.71 kWH** respectively.

79 kWH_{total} measured over 2 days.

The peak power - around mid day - for the total PV array **2 days AFTER cleaning** the panels was **7.29 kWH** and **7.44 kWH** respectively.

88.1 kWH_{total} measured over 2 days.
